# Shoreline Situation Report SURRY COUNTY, VIRGINIA

Chesapeake Research Consortium Report Number 50  
Special Report in Applied Marine Science and Ocean Engineering Number 112 of the

VIRGINIA INSTITUTE OF MARINE SCIENCE  
Gloucester Point, Virginia 23062

1976

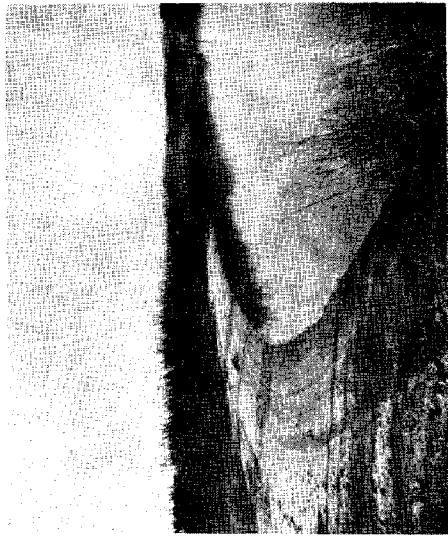
FIGURE 3

FIGURE 3: Beach and marsh at Hog Island State Waterfowl Refuge. The entire area is preserved.

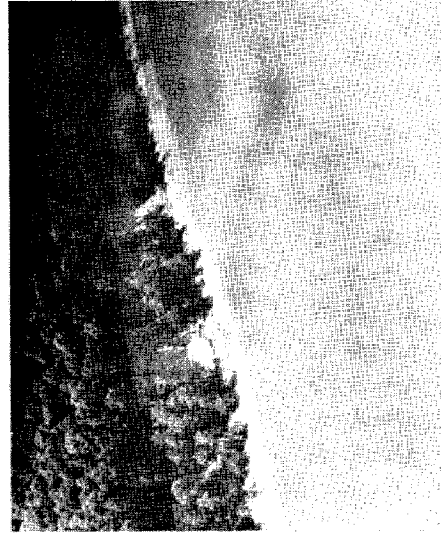
FIGURE 5

FIGURE 5: Bluffs between Broad Swamp and Wakefield. The bluffs here, as in most of Surry, are continually eroding. Rain runoff, wind and wave actions all contribute to this problem.

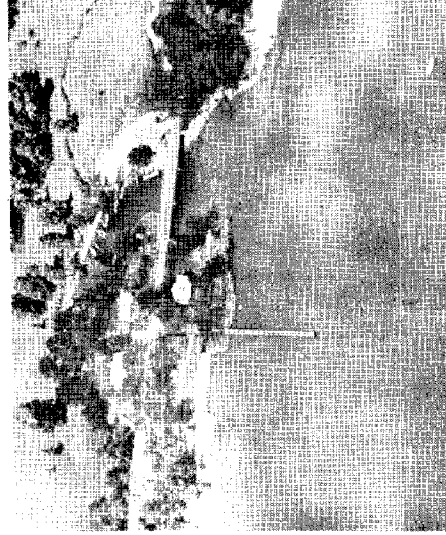
FIGURE 6

FIGURE 6: A marina and several private residences are located at Pleasant Point at the mouth of Crouch Creek.

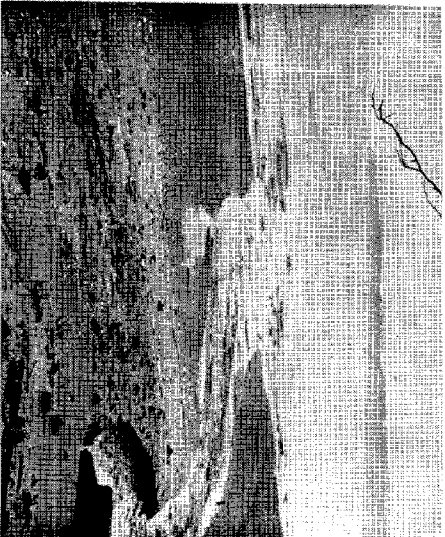
FIGURE 7

FIGURE 7: Creek on beach at Gullford Heights. The beaches here are nourished by the erosion of the bluffs behind.
